**TEST REPORT ON INFRARED
WARNING RECEIVER (IRWR) FLIGHT
VIBRATION MEASUREMENTS**

REPORT NO: AFWAL/FIBG/79-10

TYPE OF TEST: Airborne Vibration Measurements

This test report presents data which define the vibration environments experienced by two infrared warning receiver (IRWR) units mounted on the HH-53 helicopter and the C-130E transport aircraft.

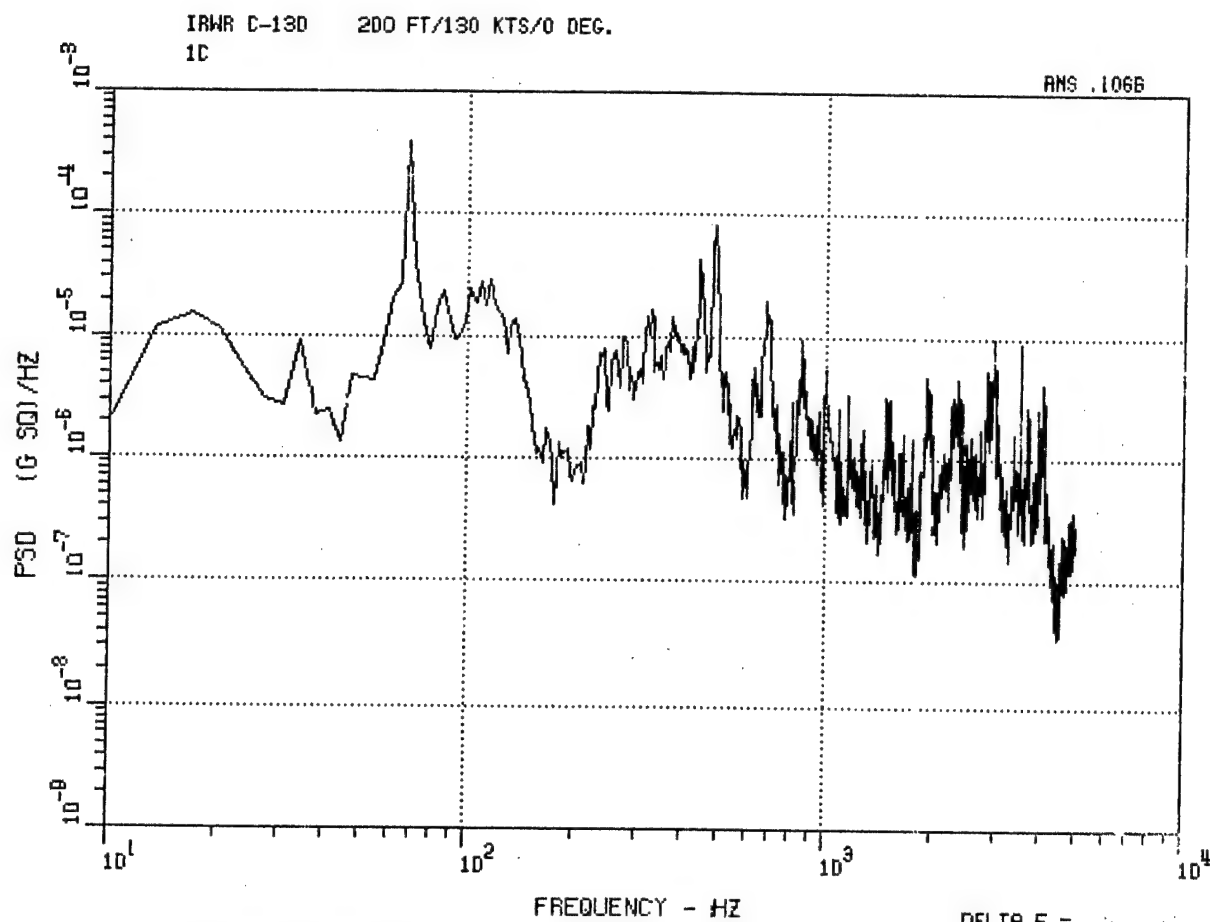
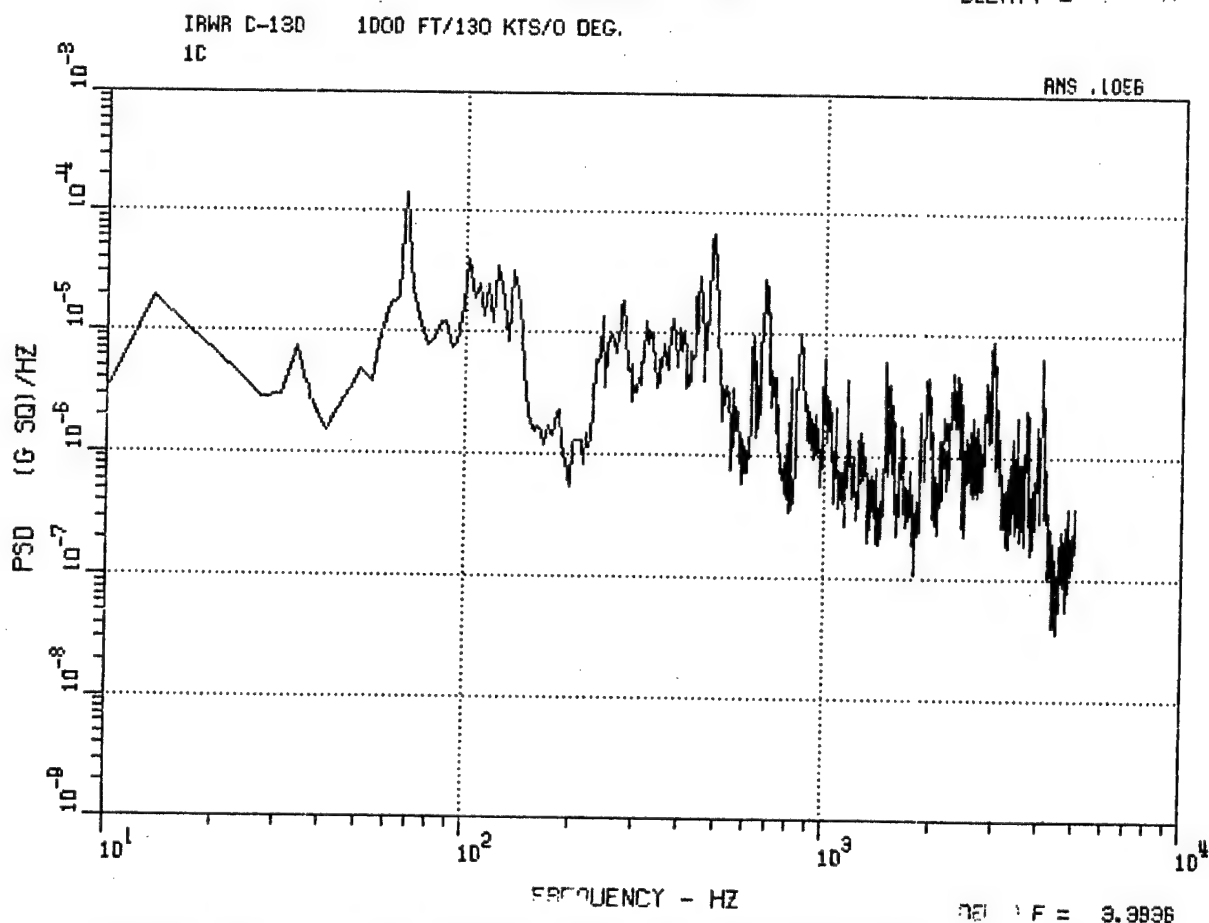
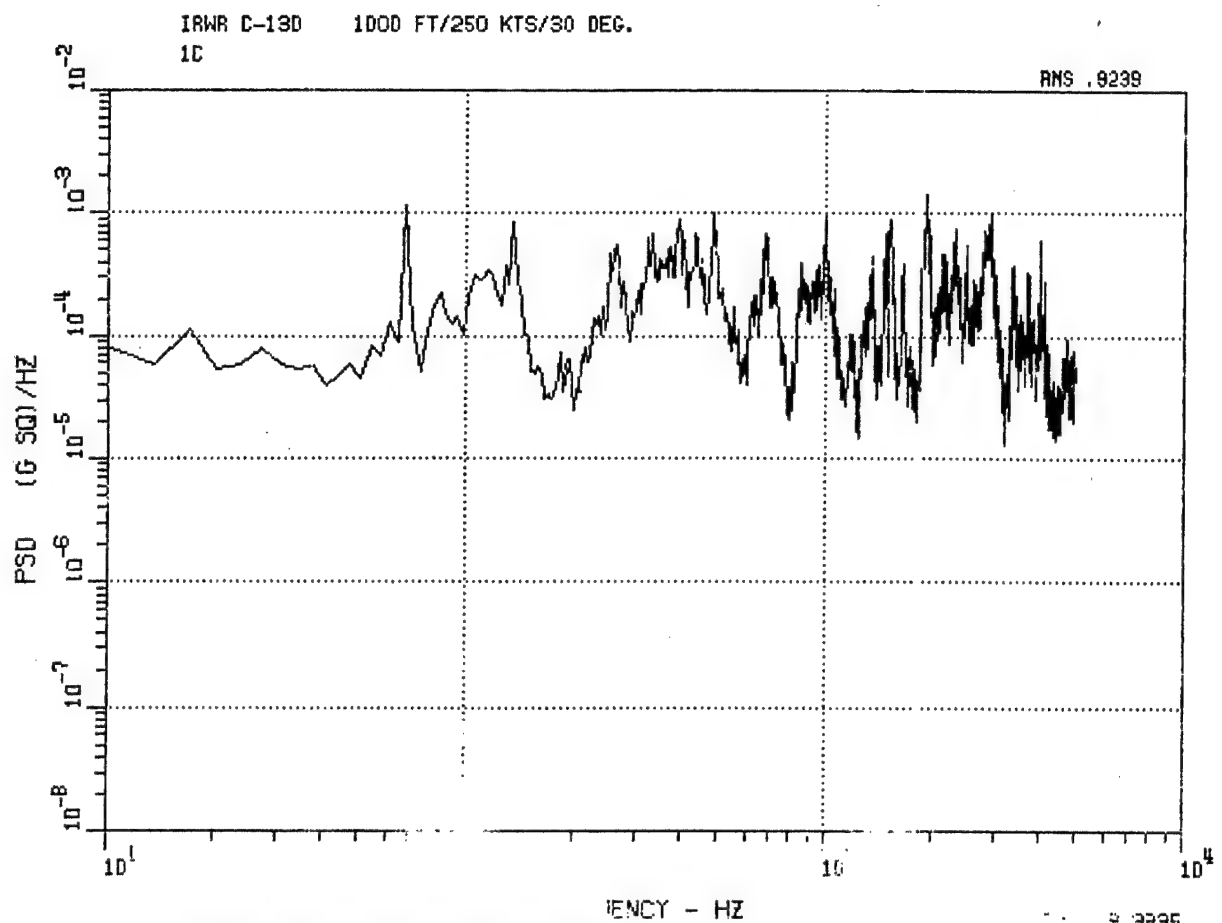
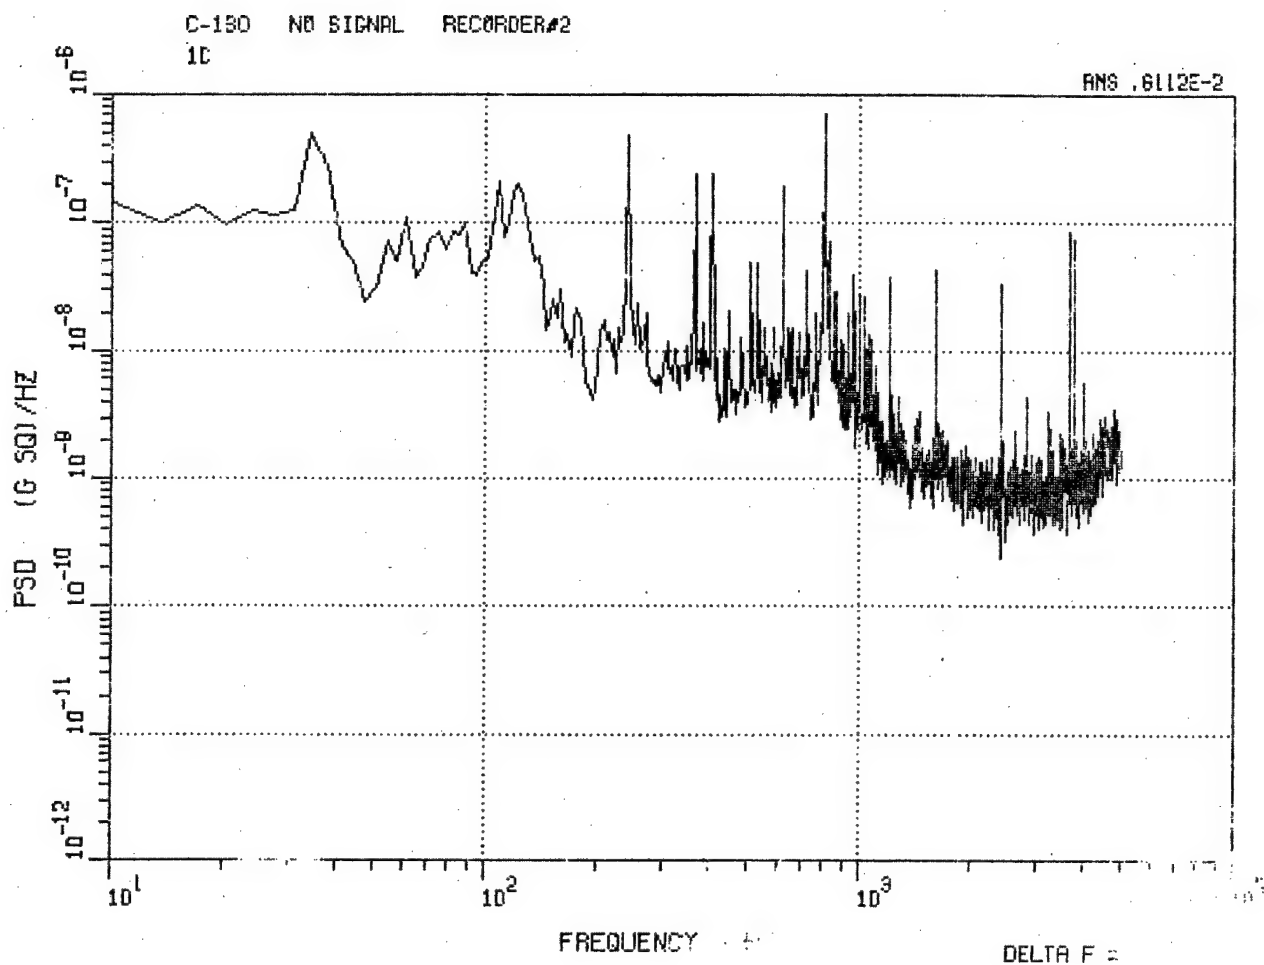
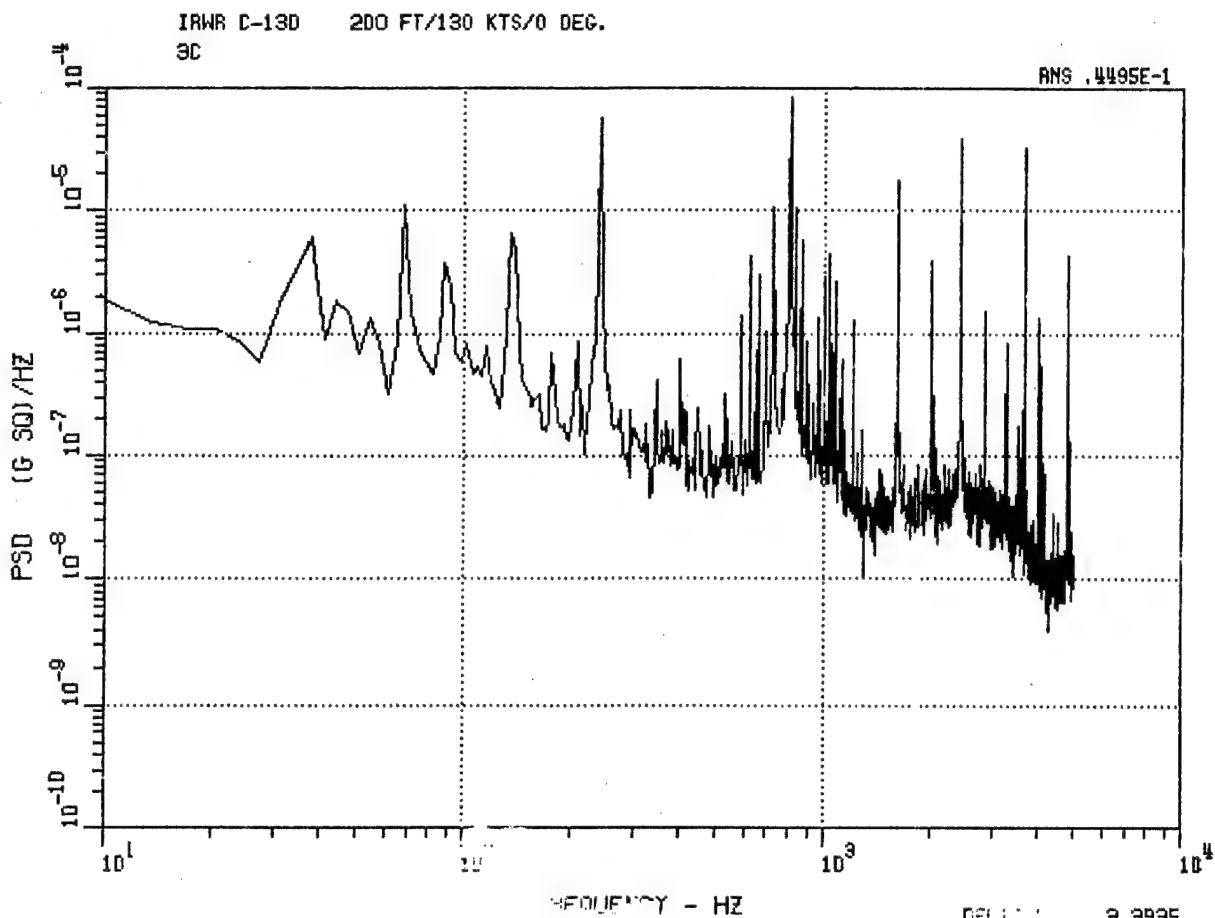
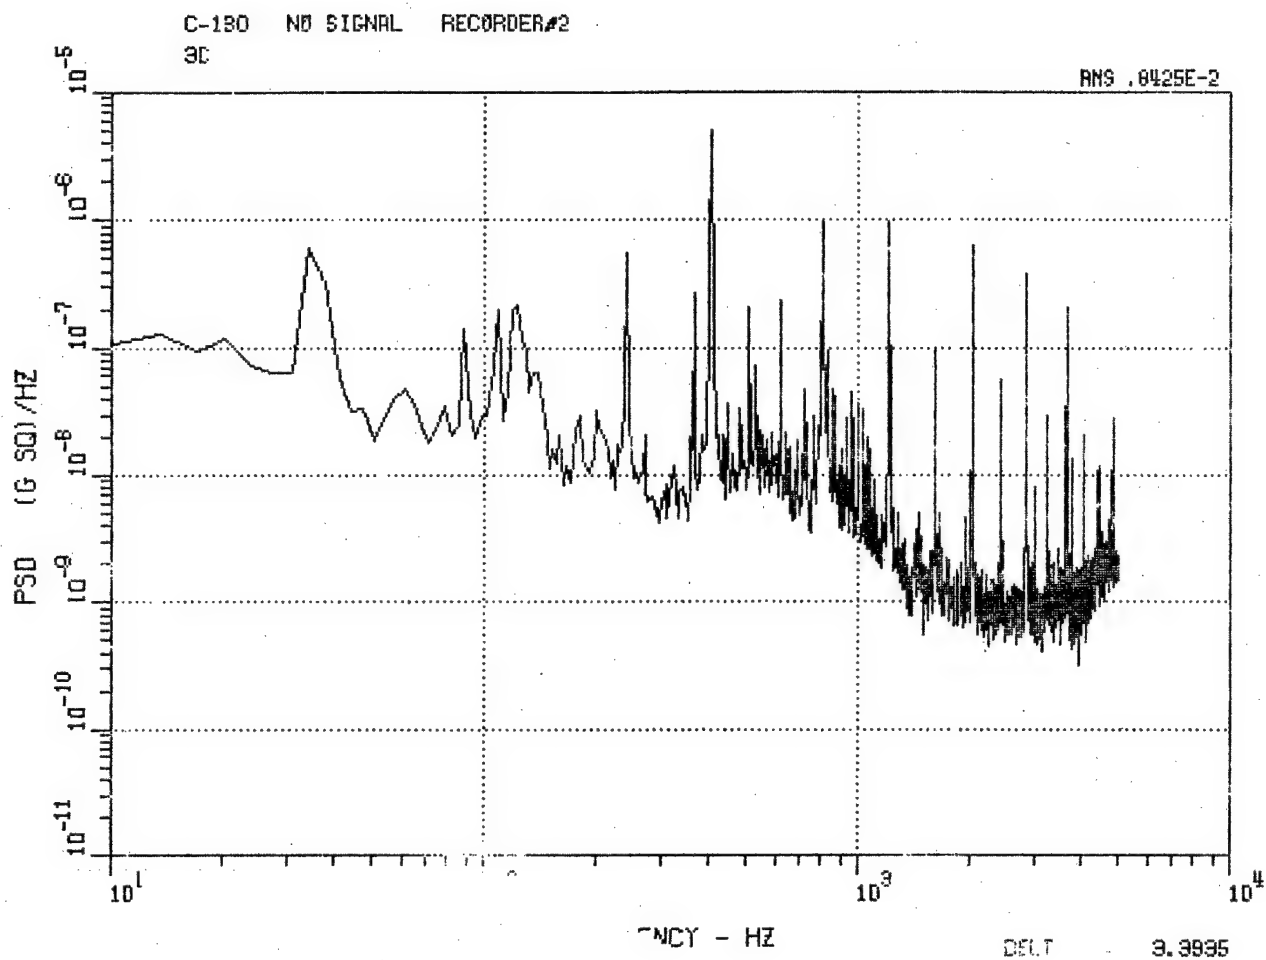
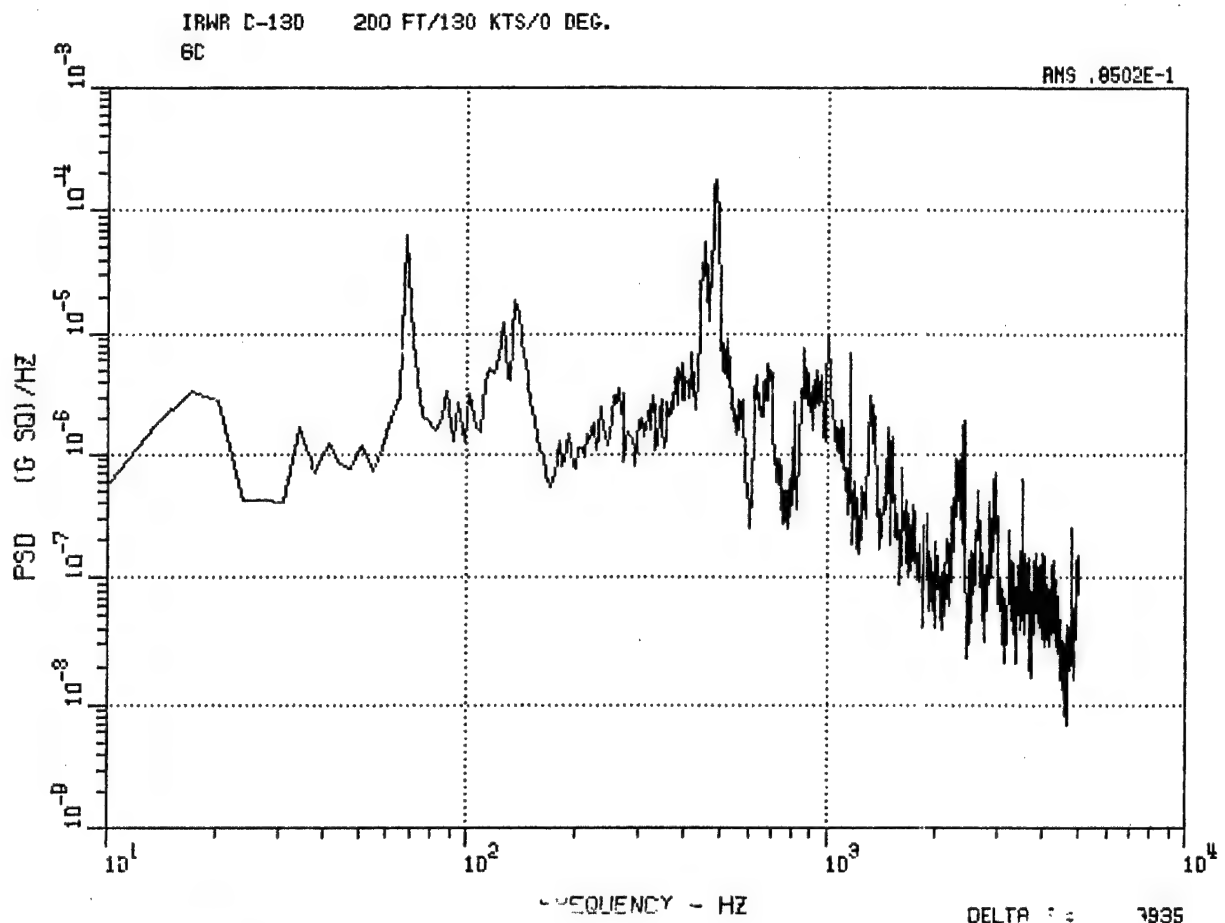
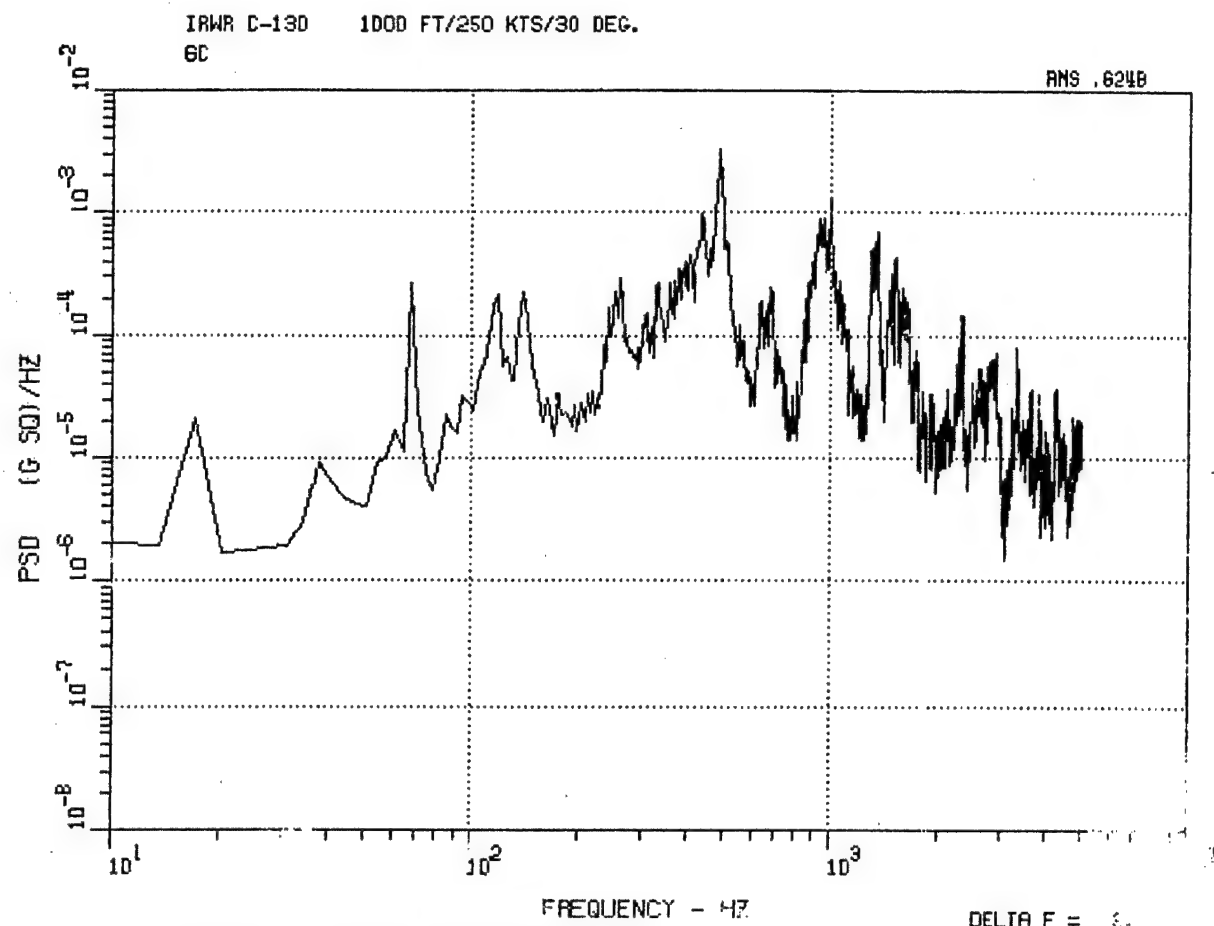
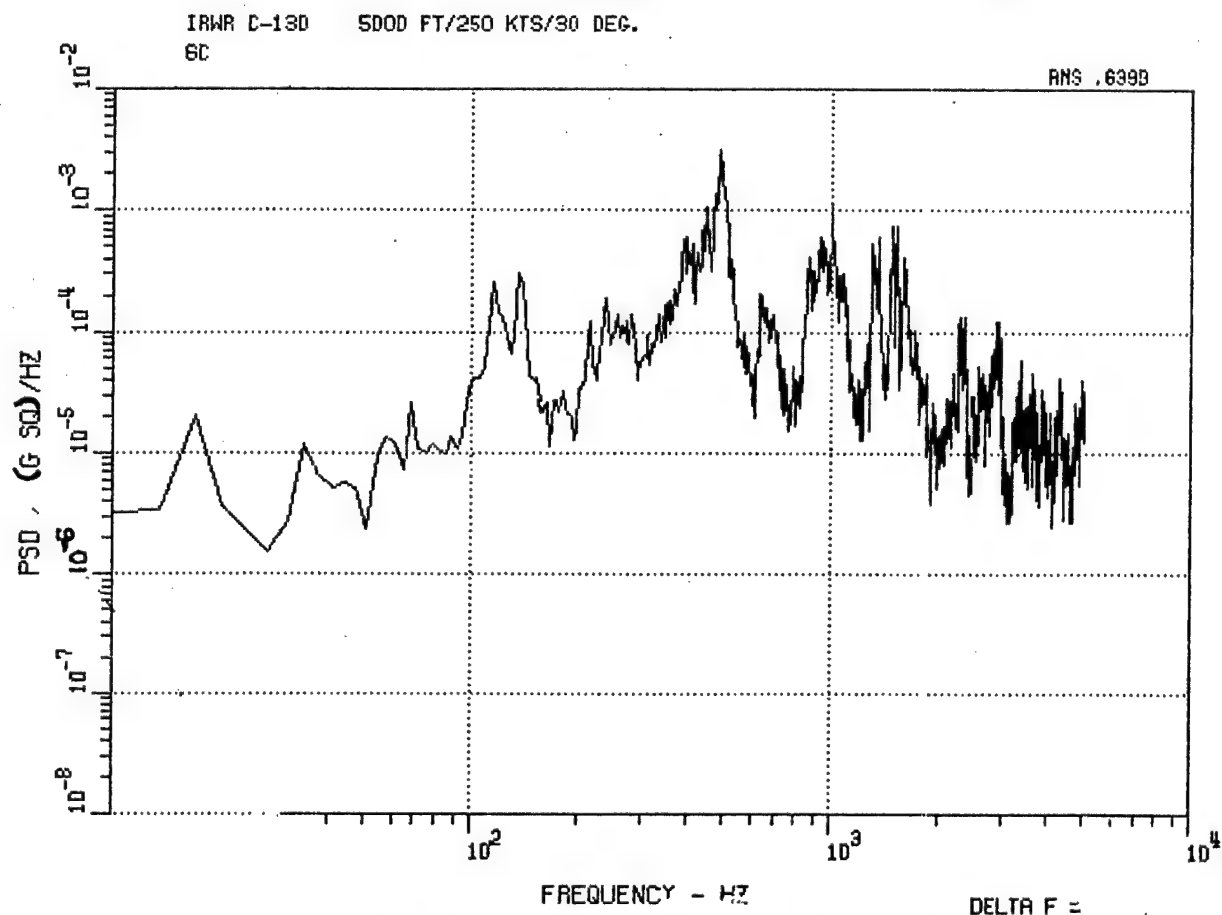
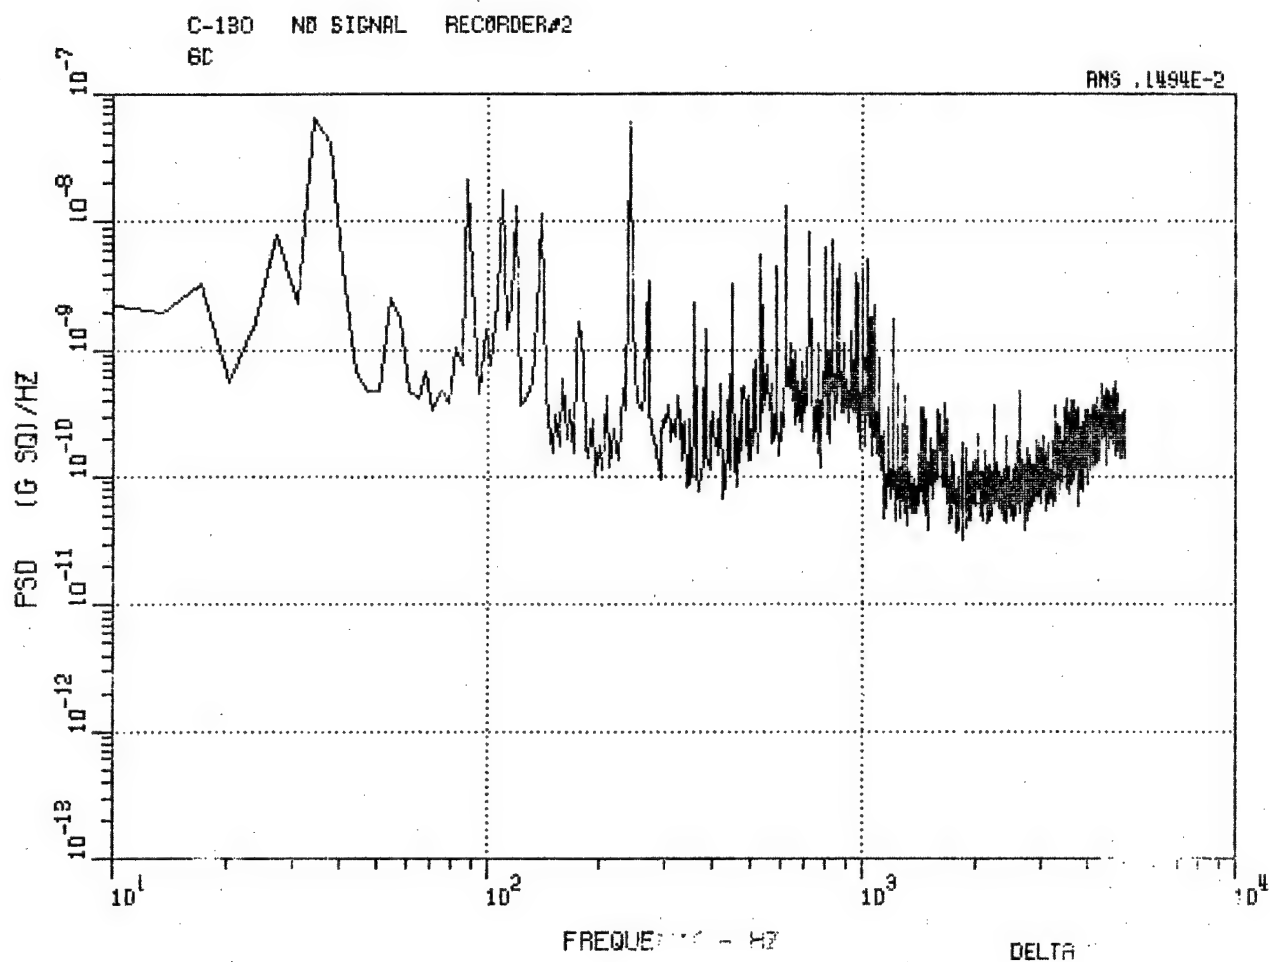
Figure 28. C-130 Center Vertical Accelerometer 1C, 200 Ft, 130 Kt, 0 Deg, and 1000 Ft, 130 Kt, 0 Deg.

Figure 30. C-130 Center Vertical Accelerometer 1C, 1000 Ft, 250 Kt, 30 Deg, and 5000 Ft, 250 Kt, 30 Deg.

Figure 31. C-130 Center Vertical Accelerometer 1C,
No-Signal Record.

Figure 32. C-130 Center Lateral Accelerometer 3C, 200 Ft, 130 Kt, 0 Deg, and 1000 Ft, 130 Kt, 0 Deg.

Figure 34. C-130 Center Lateral Accelerometer 3C, 1000 Ft, 250 Kt, 30 Deg, and 5000 Ft, 250 Kt, 30 Deg.

Figure 35. C-130 Center Lateral Accelerometer 3C,
No-Signal Record.

Figure 36. C-130 Center Longitudinal Accelerometer 6C,
200 Ft, 130 Kt, 0 Deg, and 1000 Ft, 130 Kt,
0 Deg.

Figure 38. C-130 Center Longitudinal Accelerometer 6C,
1000 Ft, 250 Kt, 30 Deg, and 5000 Ft, 250 Kt,
30 Deg.

Figure 39. C-130 Center Longitudinal Accelerometer 6C,
No-Signal Record.

The AAR-44 environments on the C-130 are shown in Figures 28-43. The vertical acceleration PSDs for Sensor 1C are shown in Figures 28-41, the lateral PSDs (Sensor 3C) in Figures 32-35, and the longitudinal PSDs (Sensor 6C) in Figures 36-39. The spectra are all distinctly lower in overall rms response than the forward AAR-43 location. The acoustic noise levels, shown in Figures 41-43, are about 16 dB higher than the forward location at 130 knots airspeed and are about 11 dB higher at 250 kts. At the higher flight speeds the noise levels are 139-140 dB, which may cause some difficulty for sensitive electronics.

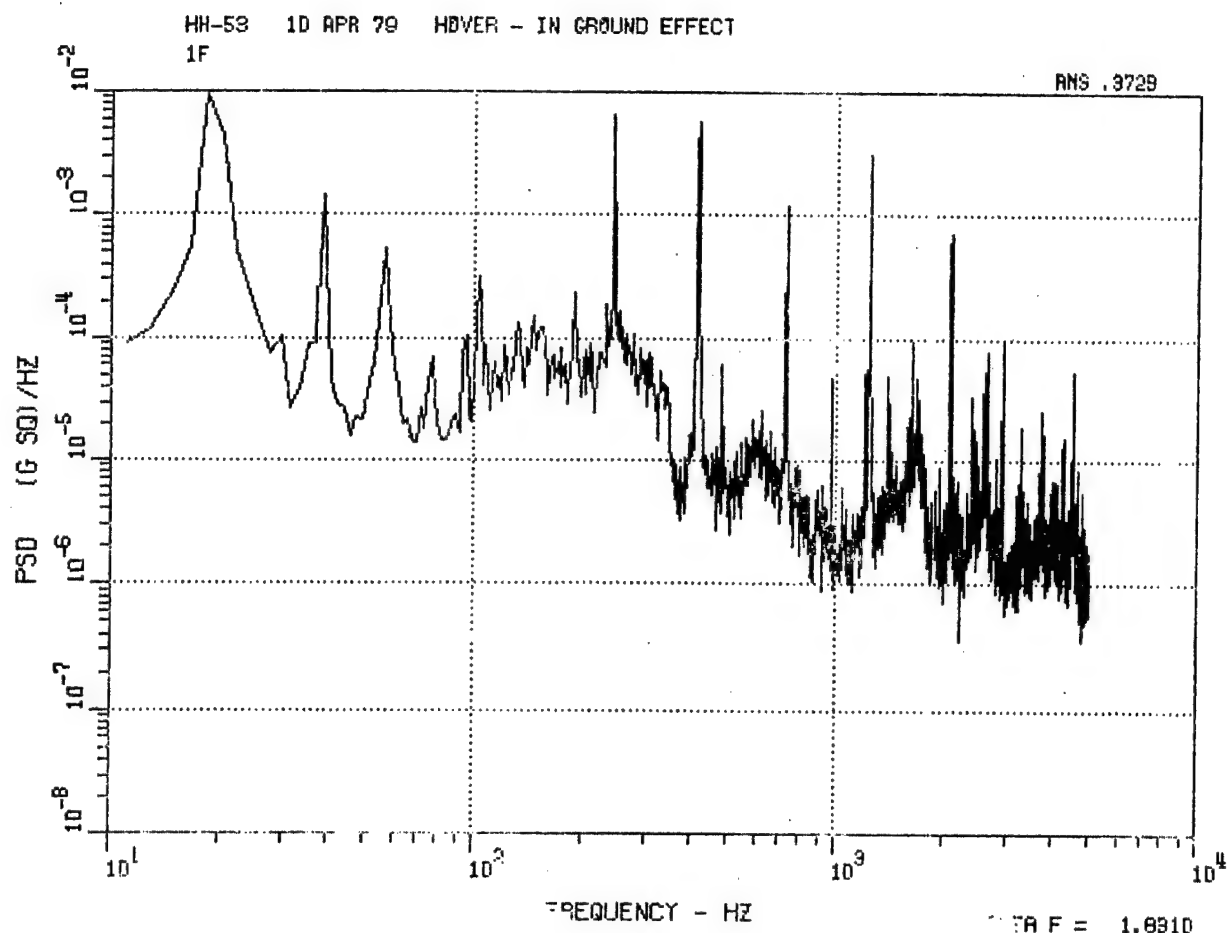
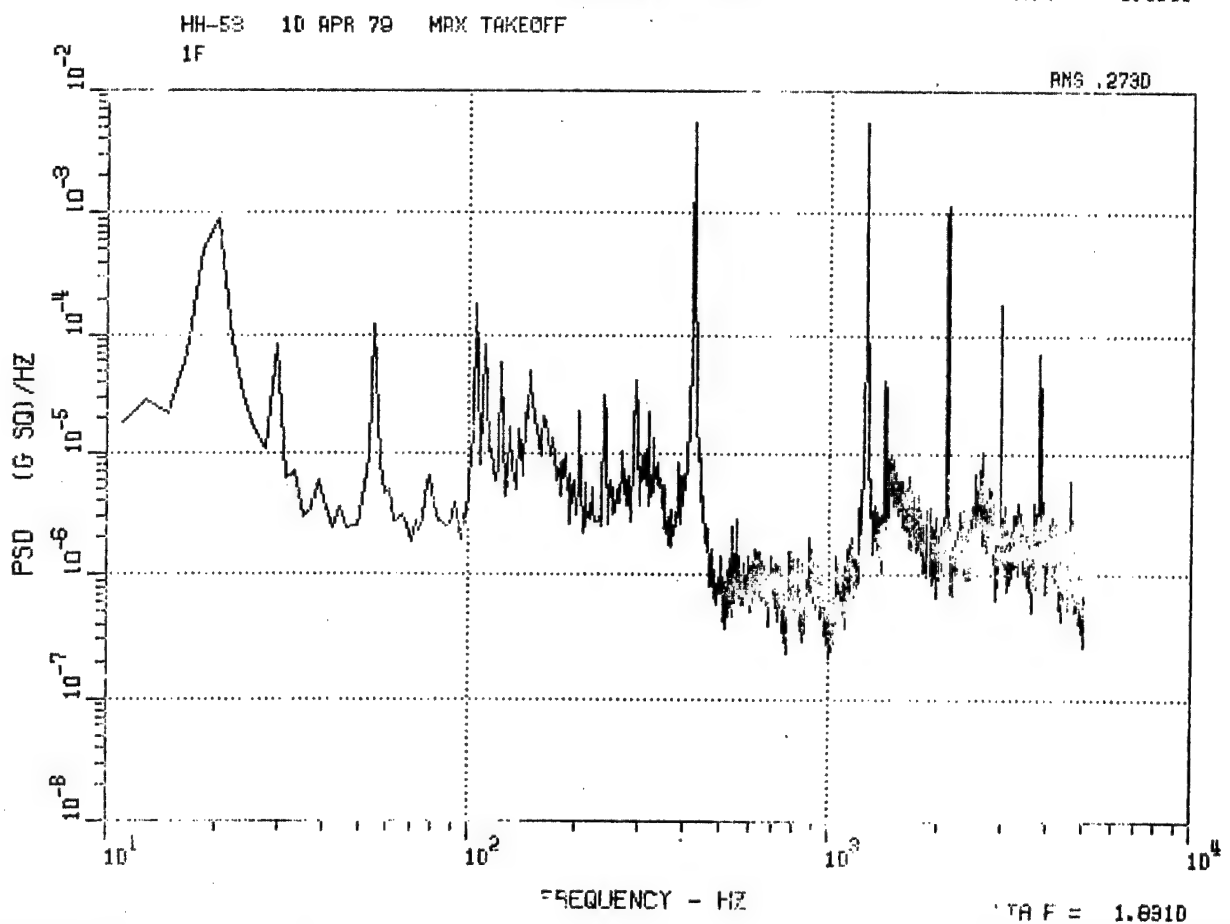
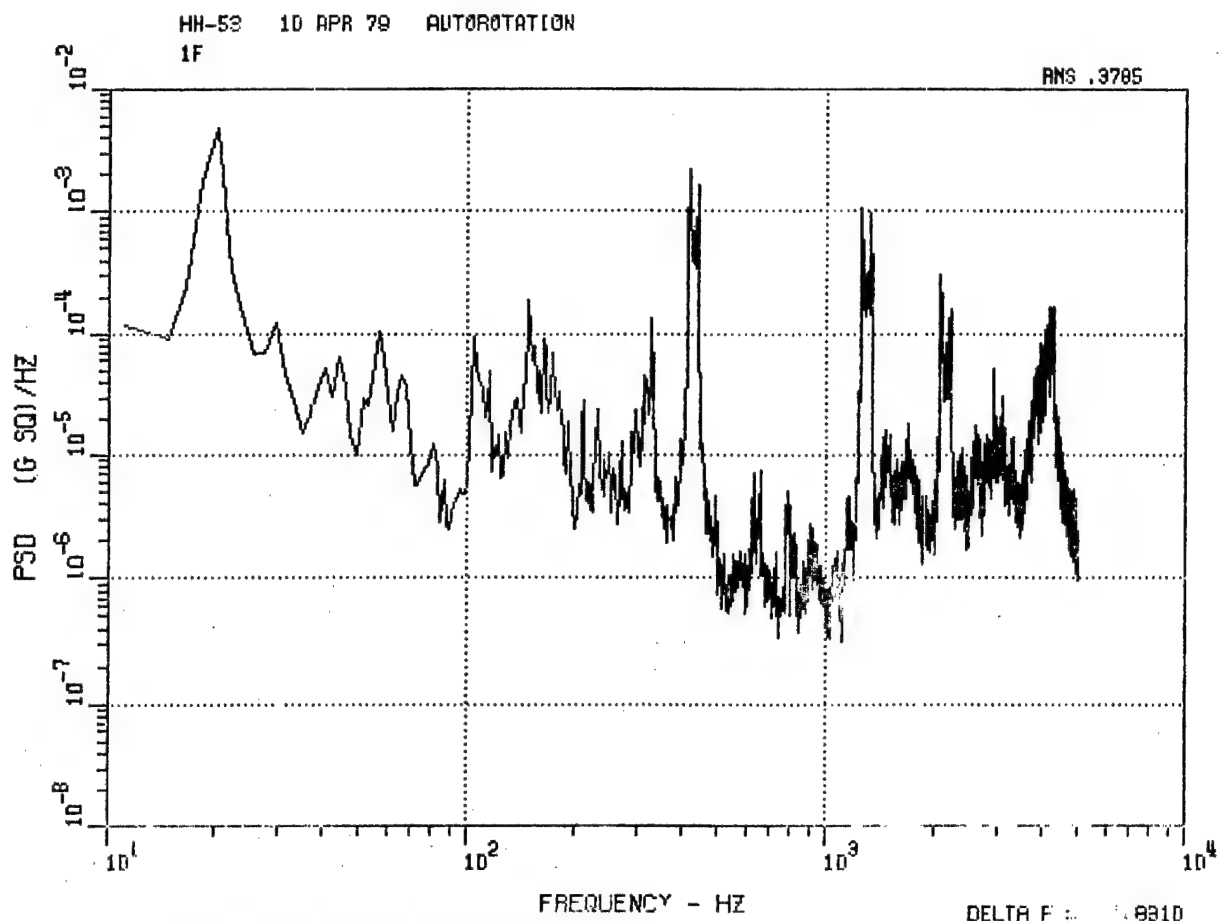
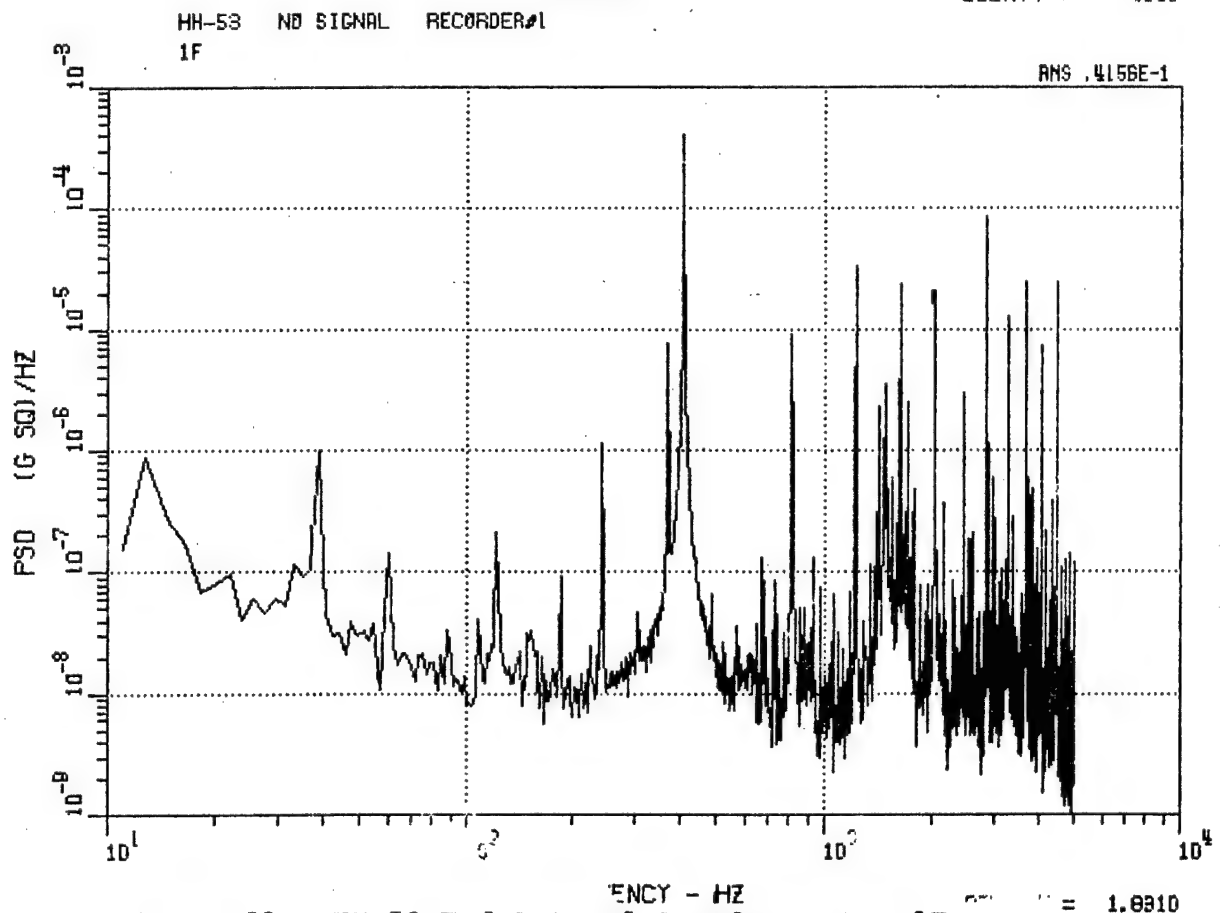
Figure 60. HH-53 Fwd Lateral Accelerometer 1F,
Hover IGE and Max Takeoff.

Figure 61. HH-53 Fwd Lateral Accelerometer 1F,
Cruise and Spiral Descent.

Figure 62. HH-53 Fwd Lateral Accelerometer 1F, Autorotation and No-Signal Record.

The HH-53 spectra are shown in Figures 60-95 for five flight conditions and for the no-signal condition. The lateral vibration at the forward AAR-43 location is shown for Sensor 1F in Figures 60-62. The responses are less than 0.5g rms and are dominated by the rotor blade passage frequencies and by the narrowband engine frequencies. The vertical accelerations, shown for Sensor 4F in Figures 63-65, are no more than 0.25g rms and the spectra show a gradual decrease at frequencies from 100 Hz to 1000 Hz. The longitudinal accelerations, represented by Sensor 6F in Figures 66-68, are also very low, reaching less than 0.3g. The noise responses from microphone MF, shown in Figures 69-71, are a moderate 122-130 dB. The greatest response is at the 18-Hz rotor slapping frequency.

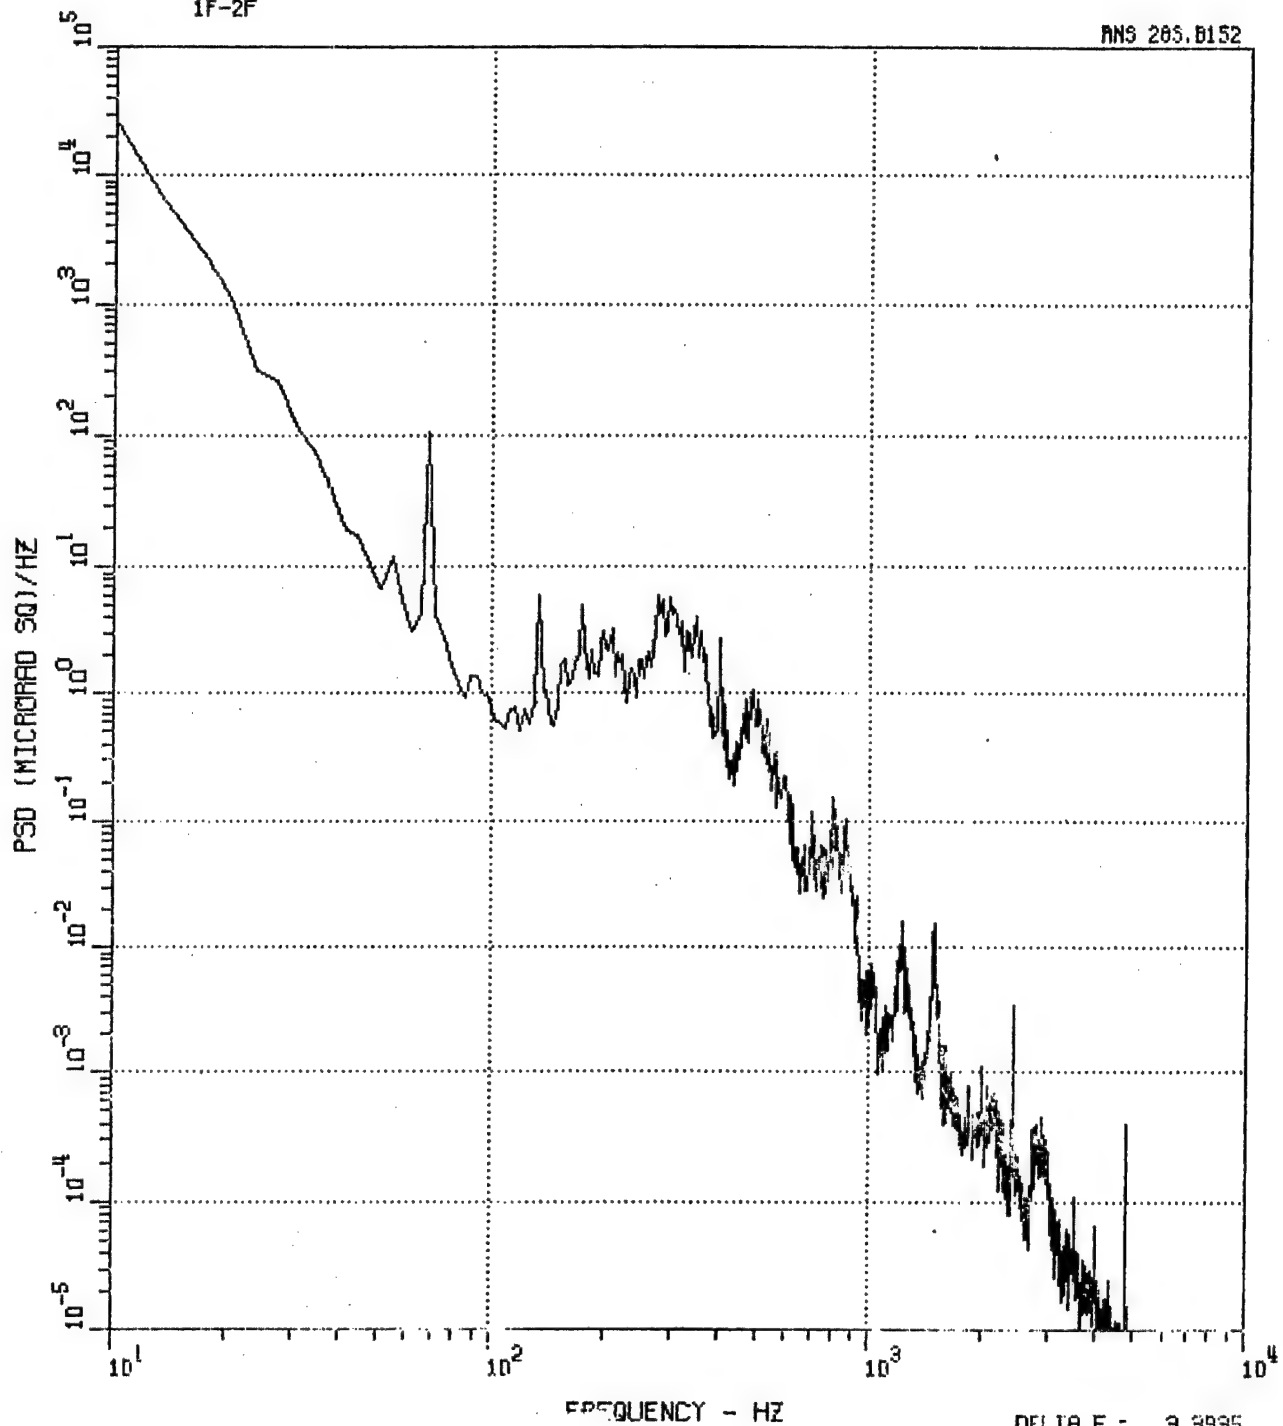
Figure 96. C-130 Fwd Roll PSD, 1F-2F, 1000 Ft, 250 Kt, 30 Deg.

Several pairs of linear accelerometer signals on the C-130 were combined to produce a measure of the angular accelerations experienced by the sensors. The sensors chosen are shown in Table 7 and the results are shown in Figures 96-100 for the selected flight condition of 250 knots, 30° bank, and 1000 feet altitude. The results, shown in PSDs of microradians squared per hertz, are for information only and were not used to evaluate the sensor vibration environments.

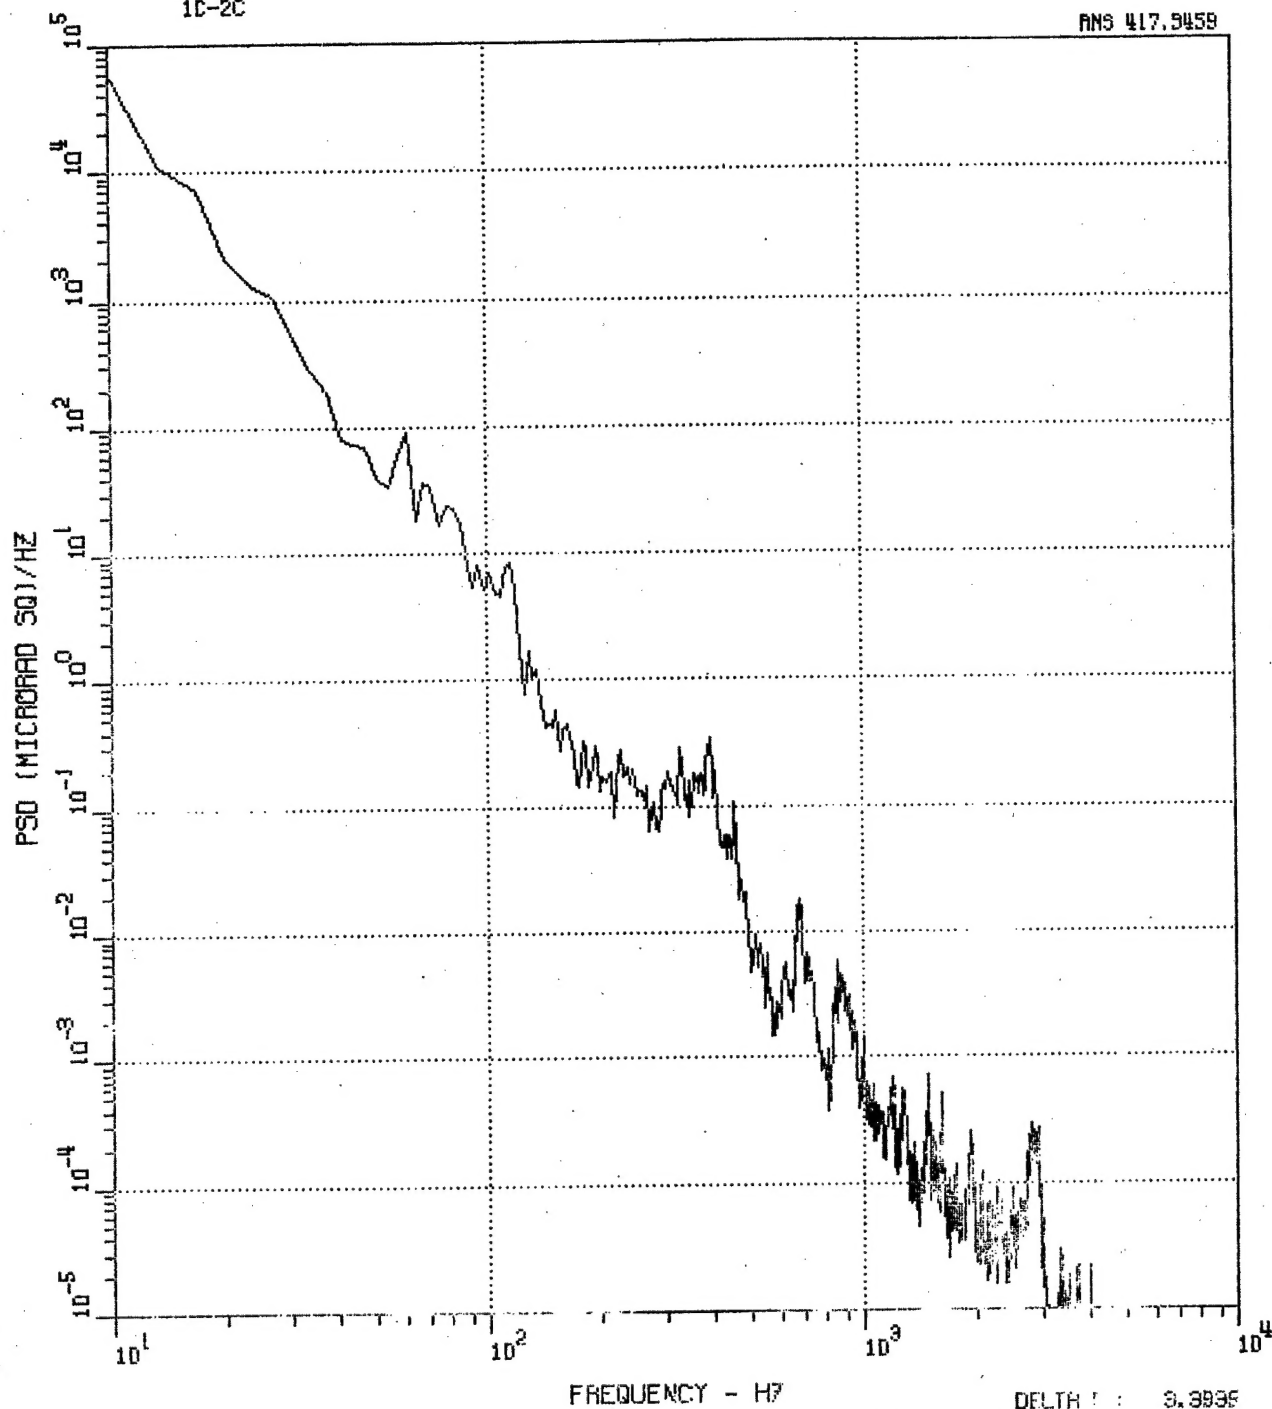
Figure 97. C-130 Center Roll PSD, 1C-2C, 1000 Ft, 250 Kt, 30 Deg.

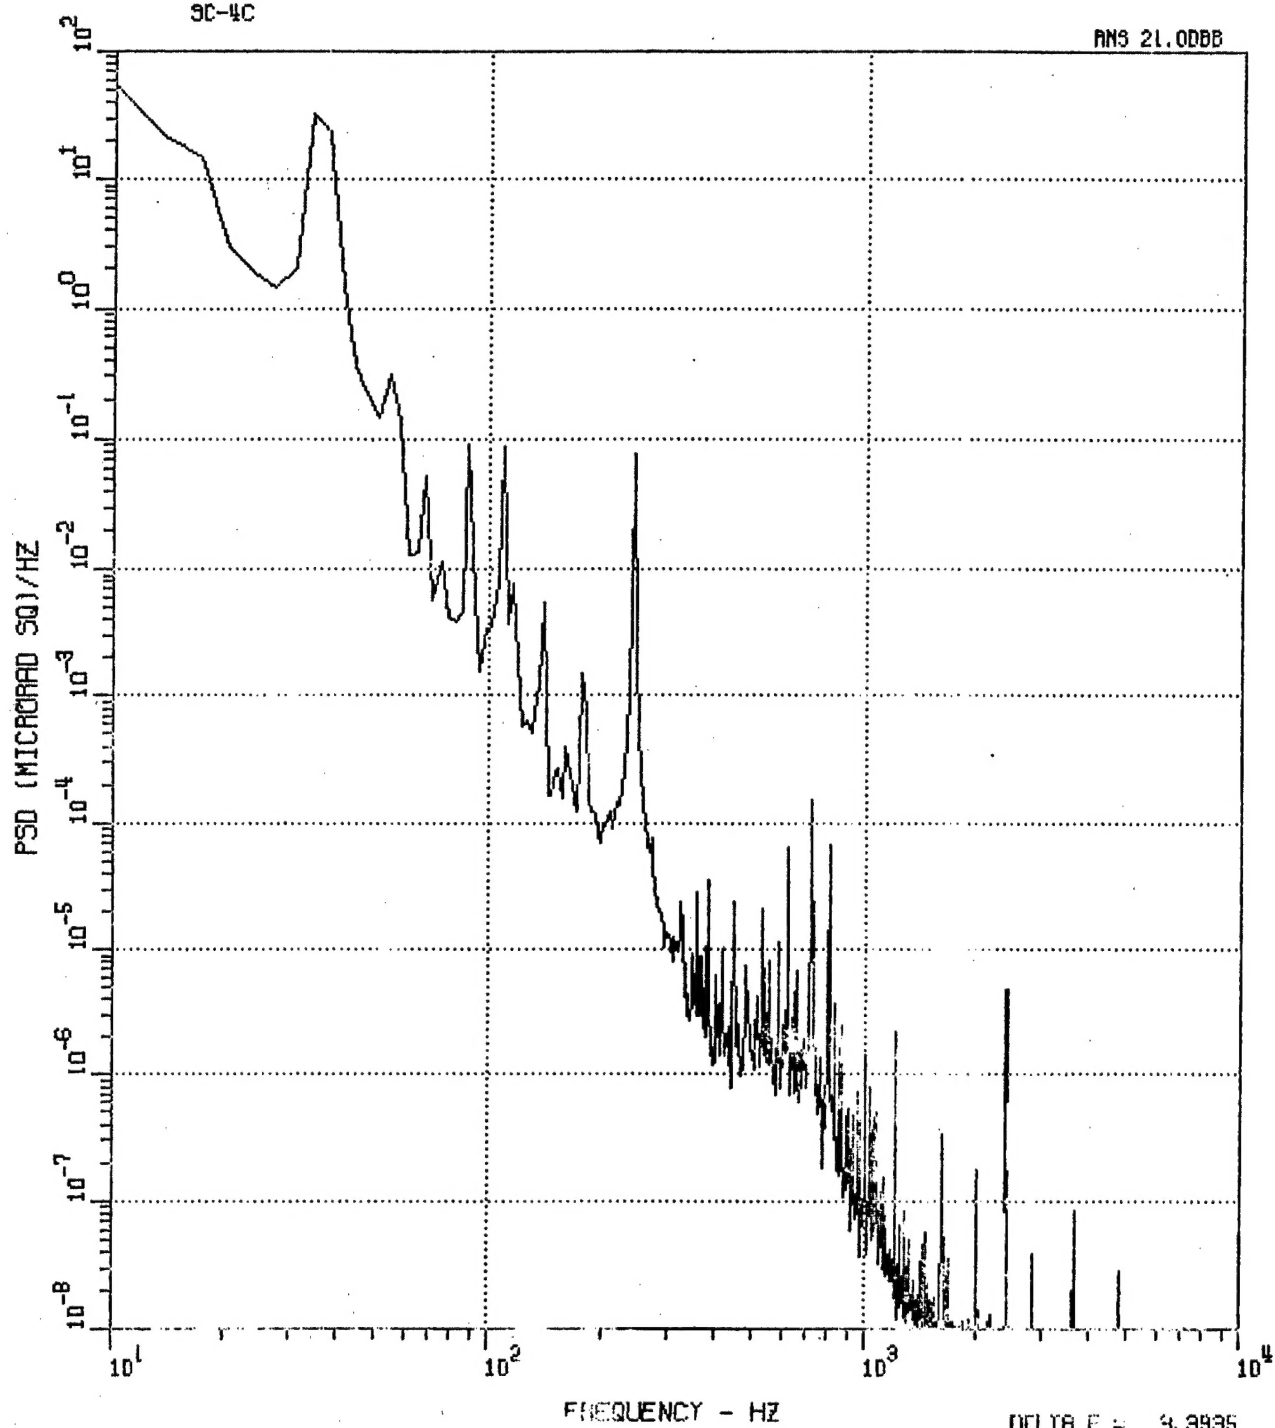
Figure 98. C-130 Center Yaw PSD; 3C-4C, 1000 Ft, 250 Kt, 30 Deg. DELTA F = 4.8935
